FORMER CEGB CONTROL CENTRE,  
BECCA HALL, ABERFORD,  
WEST YORKSHIRE

BUILDING RECORDING

Report no: 2012/436.R01  
Version: Final  
Date: October 2012  
Author: Shaun Richardson & Ed Dennison

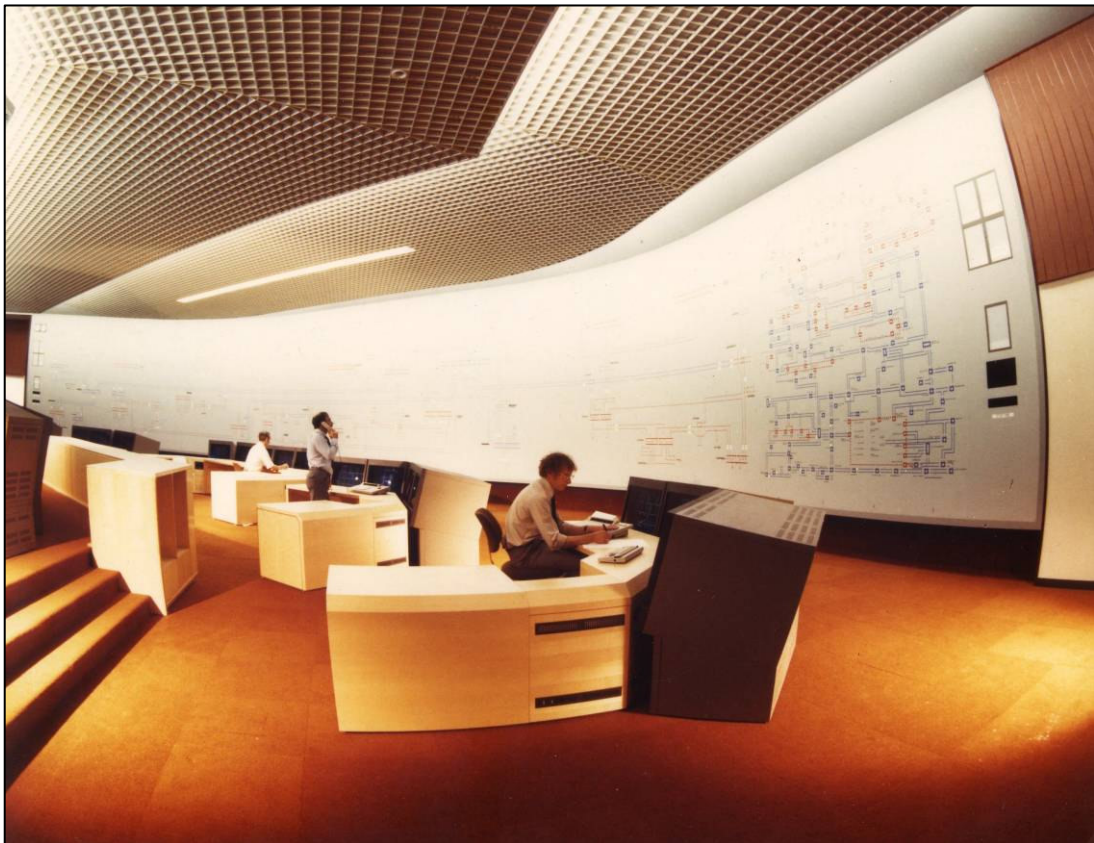
Top: Becca Hall and Control Centre, April 2008.  
 Bottom: Control room (1F15) in use, showing mimic board in operation, late 1990s.

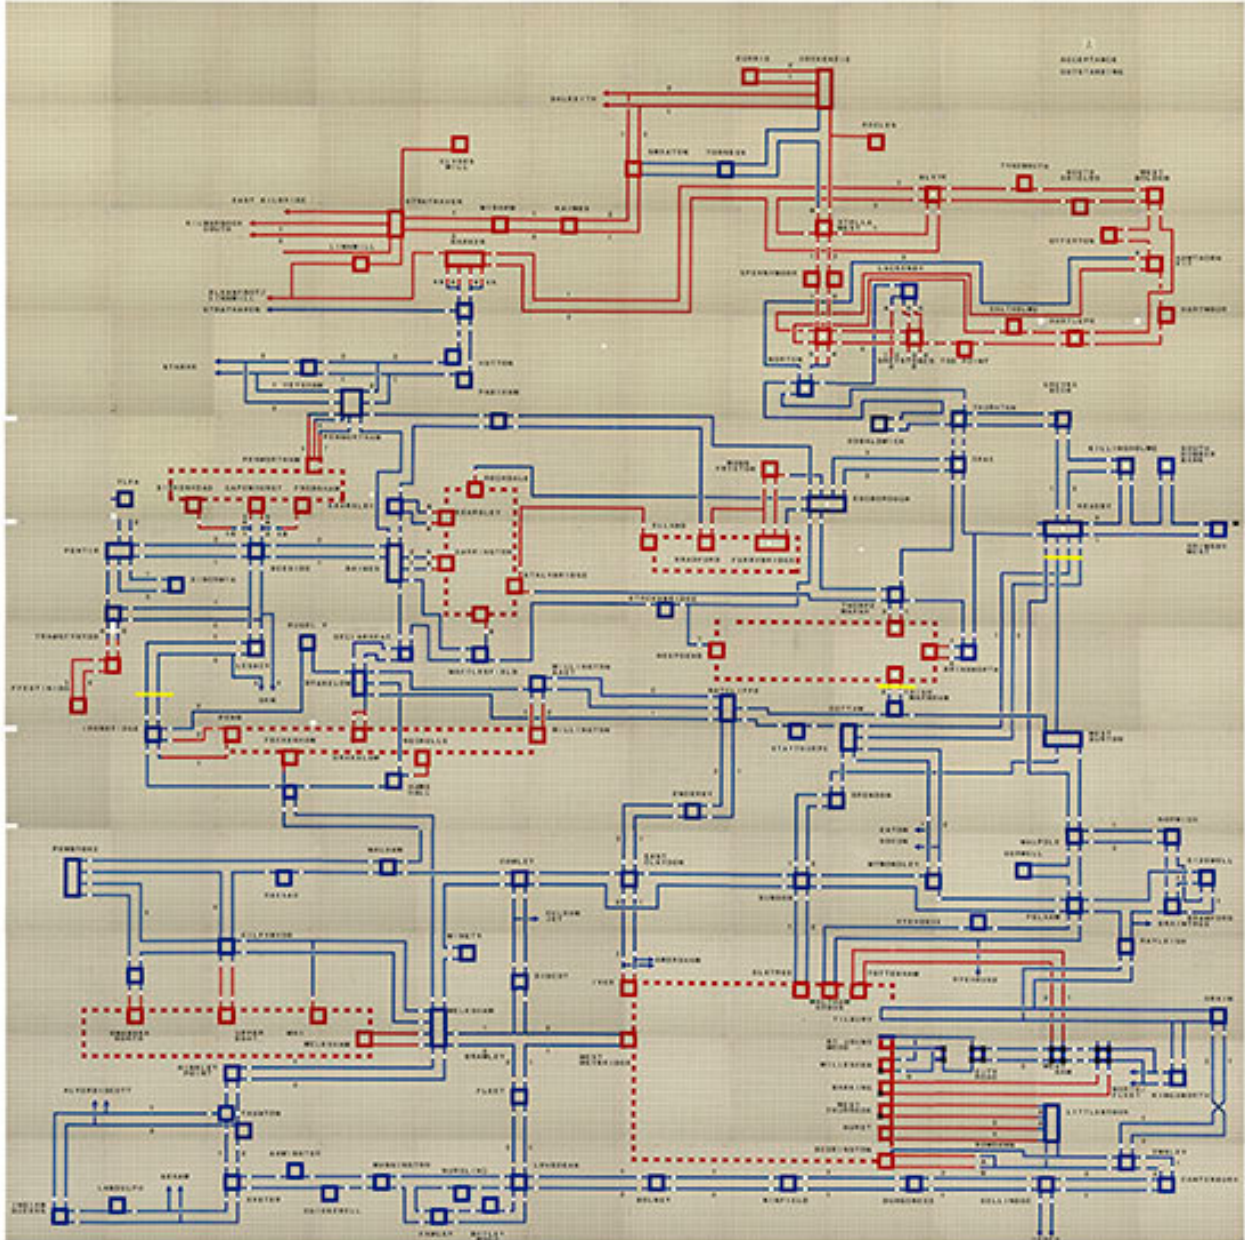
PROJECT CEGB CONTROL CENTRE, BECCA HALL	
TITLE REMOVED SECTION OF MIMIC BOARD	
SCALE NTS	DATE OCT 2012
EDAS	FIGURE 7

Photograph of section of mimic board removed from site in December 2011 for conservation and storage at the Museum of Science and Industry (MSIM) in Manchester.

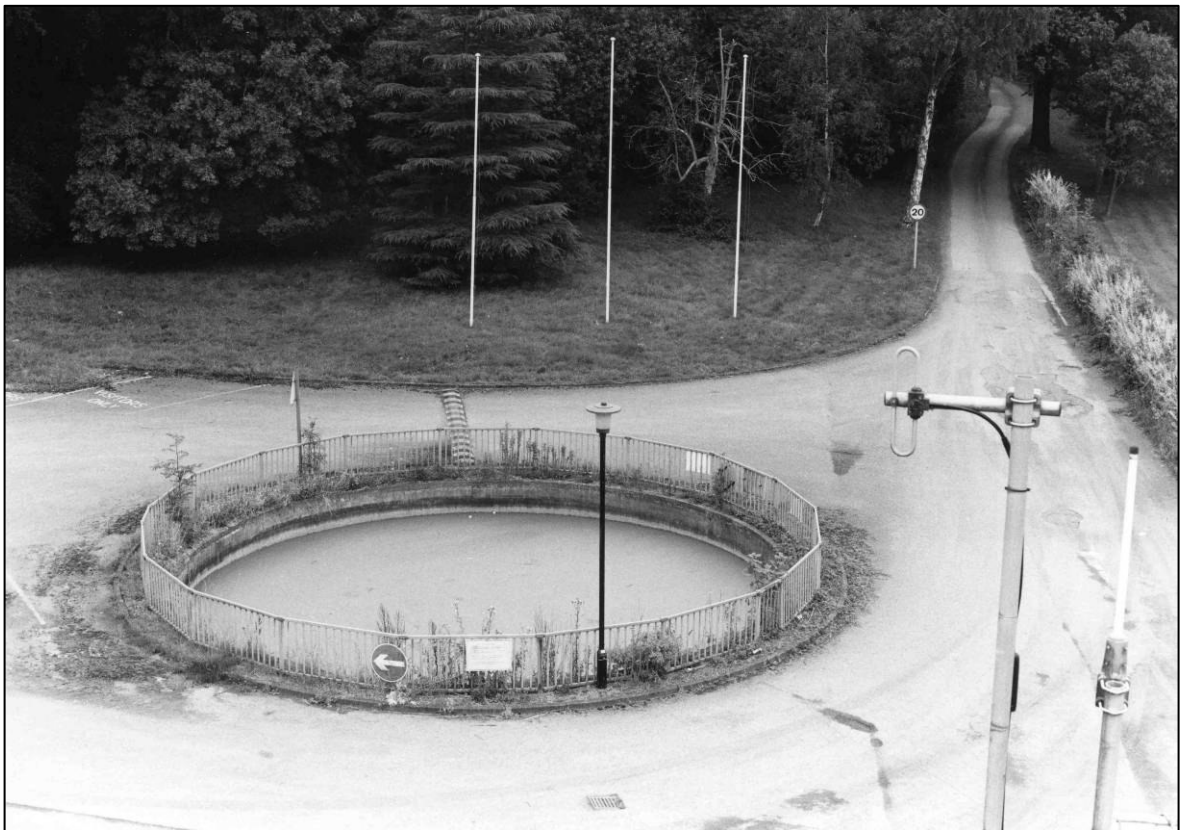
Plate 4: Fire hydrant pond, looking NE (photo 9/6).

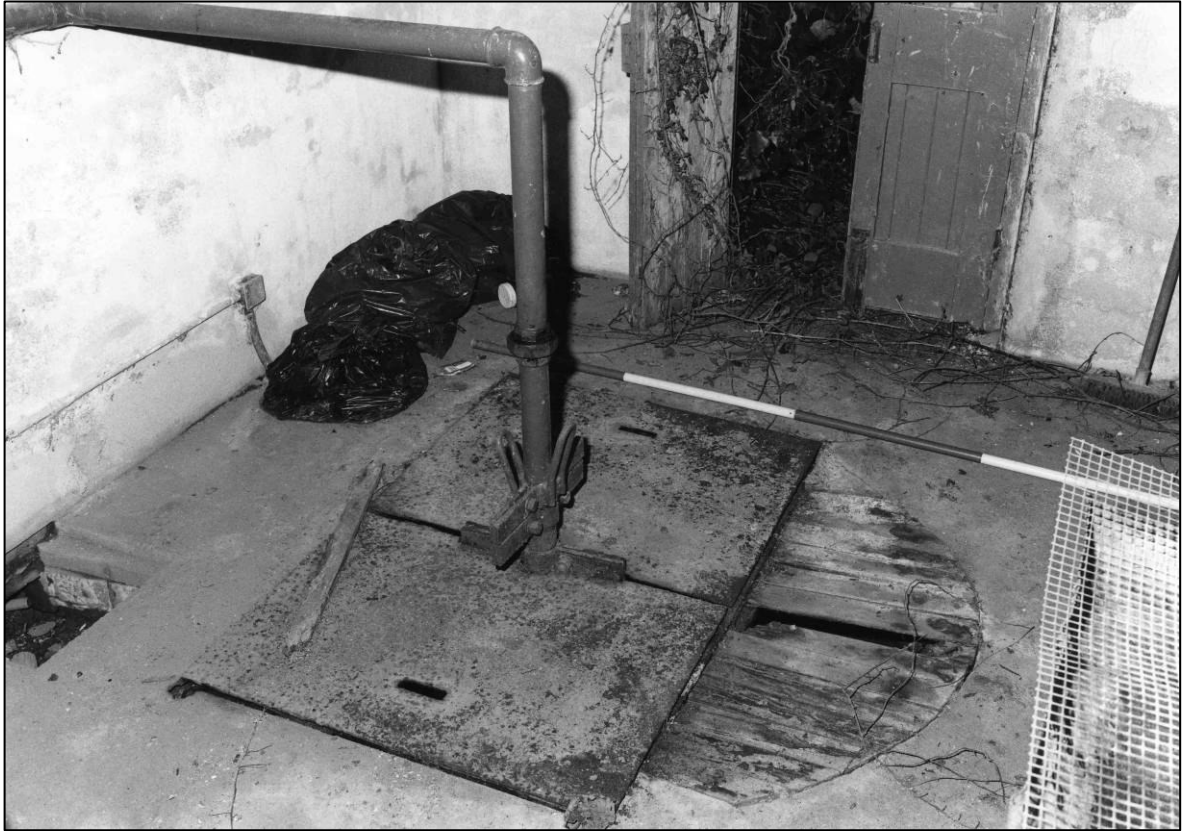
Plate 9: Interior of pump house, well, looking W (photo 9/11).

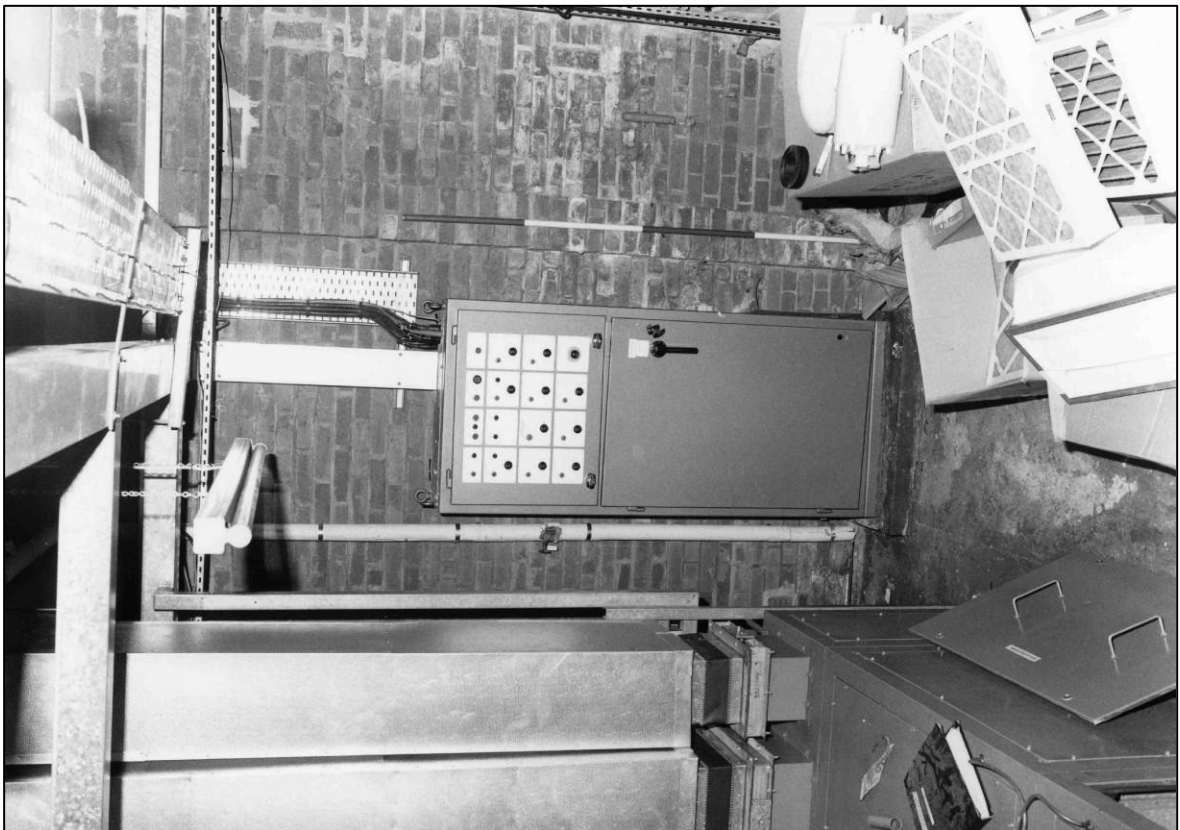
Plate 52: Air Conditioning Plant Room (GF9), looking SW (photo 4/16) (top to left).

The air conditioning plant room is accessed from a small circulation space off the west side of corridor GF8. A doorway labelled 'C9' at the north-east corner leads onto a small flight of wooden steps, which descend to the floor of the plant room; the plant room is a sunken space, the floor being set c.1m lower than the circulation space outside. The plant room is floored with concrete and has bare brick walls, with a concrete ceiling over. The majority of the floor space is occupied by a very substantial air conditioning unit. A metal wall-mounted cabinet to the west wall is labelled 'ENGINEERING OFFICE H & V CONTROL PANEL' [1].

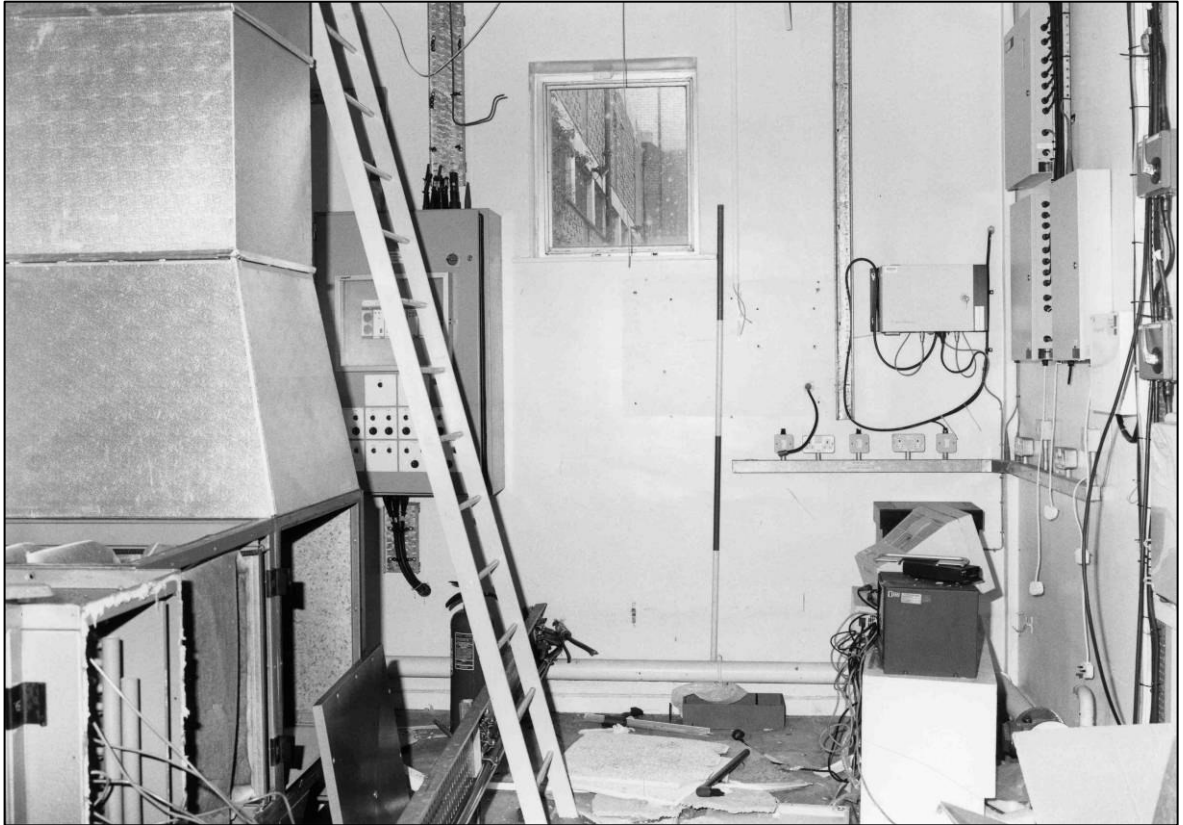
Plate 53: Air Conditioning and Security Room (GF7), looking NW (photo 4/11).

The room once accessed from the south end of the corridor's [GF8] east wall houses the remnants of air-conditioning plant, security cameras and radio equipment. The majority of the west side is occupied by air conditioning plant. On the south wall, two wall-mounted metal cabinets are labelled 'PADX MDF STRIPS 1-34' and 'PADX MDF STRIPS 35-68'. To the north wall, there is the 'PROGRAMMING OFFICE AIR CONDITIONING PANEL'. A variety of further electrical equipment in the north-east corner relates to the control centre's radio transmission equipment [1].

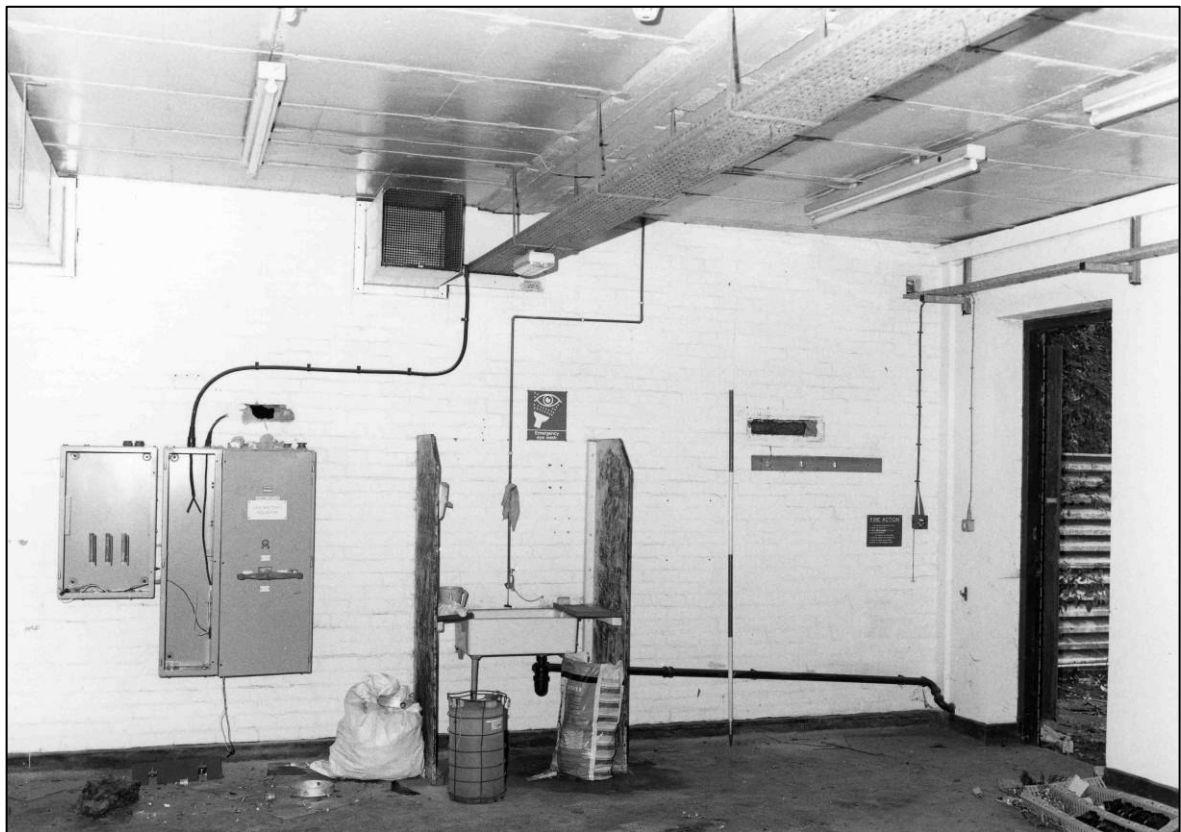
Plate 60: UPS Battery Room (GF17), looking SE (photo 9/9).

- 3.37 The west side of the central part of the ground floor is occupied by a series of spaces which can only be accessed externally comprising, from south to north, further air conditioning plant (**GF14**), the UPS Battery Room (**GF17**) (plate 60), the Essential Switchroom 1 (**GF20**) (plate 61), and Motor Generator Rooms 1 and 2 (**GF18** and **GF19**). The latter have a lift on their west side; they were designed to provide a back-up power supply for the Control Room (1F15) should the main electricity supply fail (Ray Hall, *pers. comm.*) and appear to have been built after 1993.

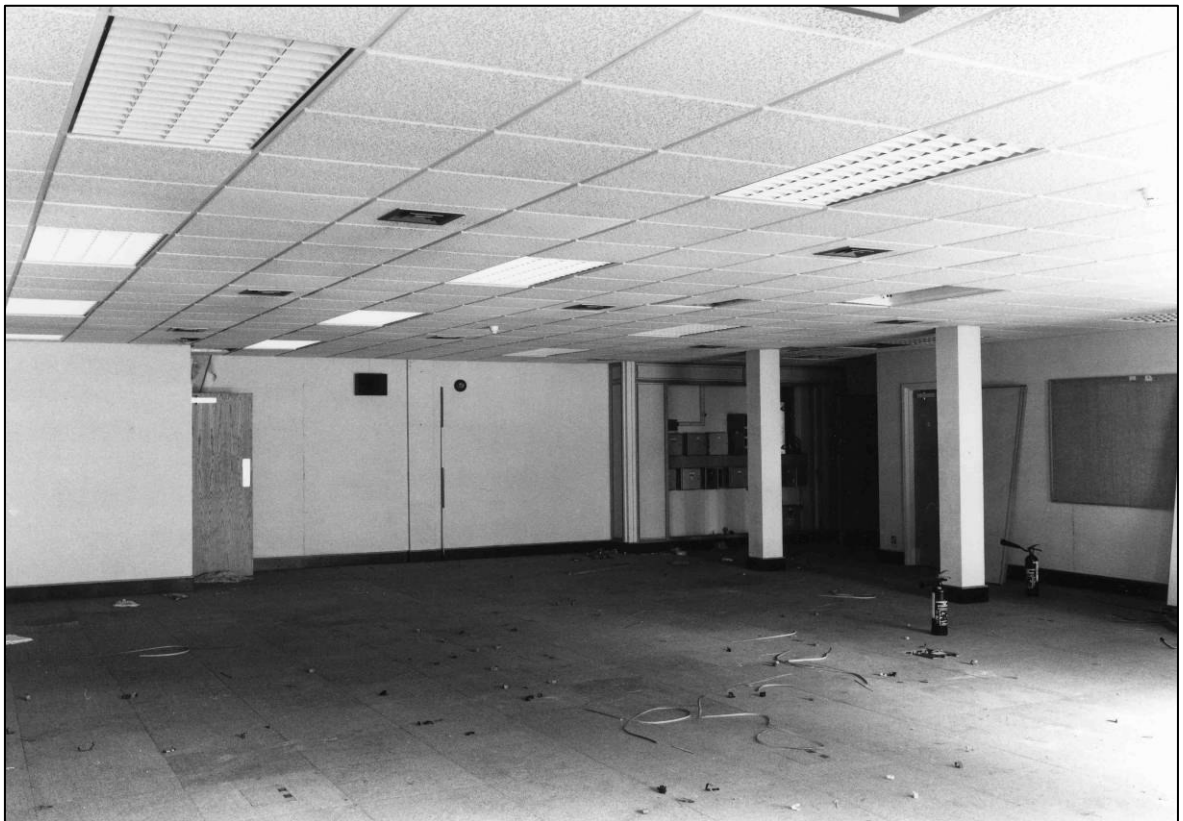
Plate 62: Business Support (GF25), looking SE (photo 5/12).

- 3.38 The majority of the rooms in the northern part of the ground floor are all accessed from the north corridor (**GF23**), which is also linked to the northern ground floor stairway (**GF28**). The north-west corner is largely formed by office space for Business Support (**GF25**) (plate 62), with Essential Switchroom 2 (**GF24**) to the south, and the Office Suite Air Conditioning room (**GF26**) to the north, only accessible externally. Little of interest survives in these rooms, although there are the remains of the electrical apparatus in the Essential Switchroom 2 (plate 63). The north-east corner comprises four rooms that formerly housed computers and equipment associated with the Interim Control Room (1F25) on the first floor. The two largest rooms, Apparatus Room 2A (**GF30**) and Apparatus Room 2B (**GF31**) were in very poor condition at the time of the survey. Apparatus Room 2A (plate 64) has a metal cabinet labelled 'BHSI ISOLATION PROCEDURE' and a de-humidifier located part way along the south wall. A doorway in the west wall gives access to the Halon Gas Store (**GF29**) which contains a number of wall-mounted metal cabinets relating to the control of the Halon gas fire-suppression system (plate 65). A larger room to the north (**GF27**) (plate 66), also reached from Apparatus Room 2A, may have formed Apparatus Room 2C. The dividing partition between Apparatus Room 2A and Apparatus Room 2B to the north is formed largely by a glazed screen, fitted with slightly darkened glass (plate 67). Apparatus

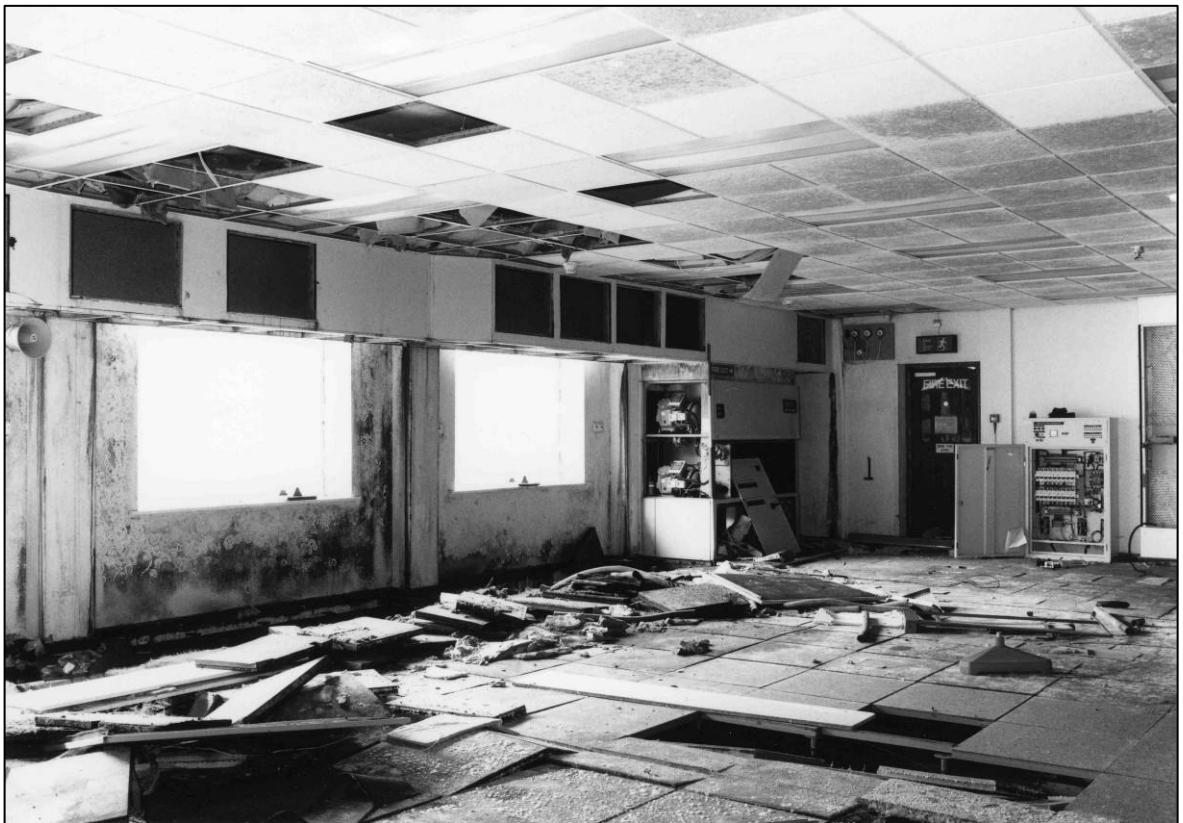
Plate 68: Apparatus Room 2B (GF31), looking NE (photo 5/8).

Room 2B (plate 68) appears once to have been very similar in terms of fittings and finishes. There is a de-humidifier positioned against the west wall and a metal cabinet labelled 'COMPUTER POWER DISTRIBUTION UNIT L' to the east wall.

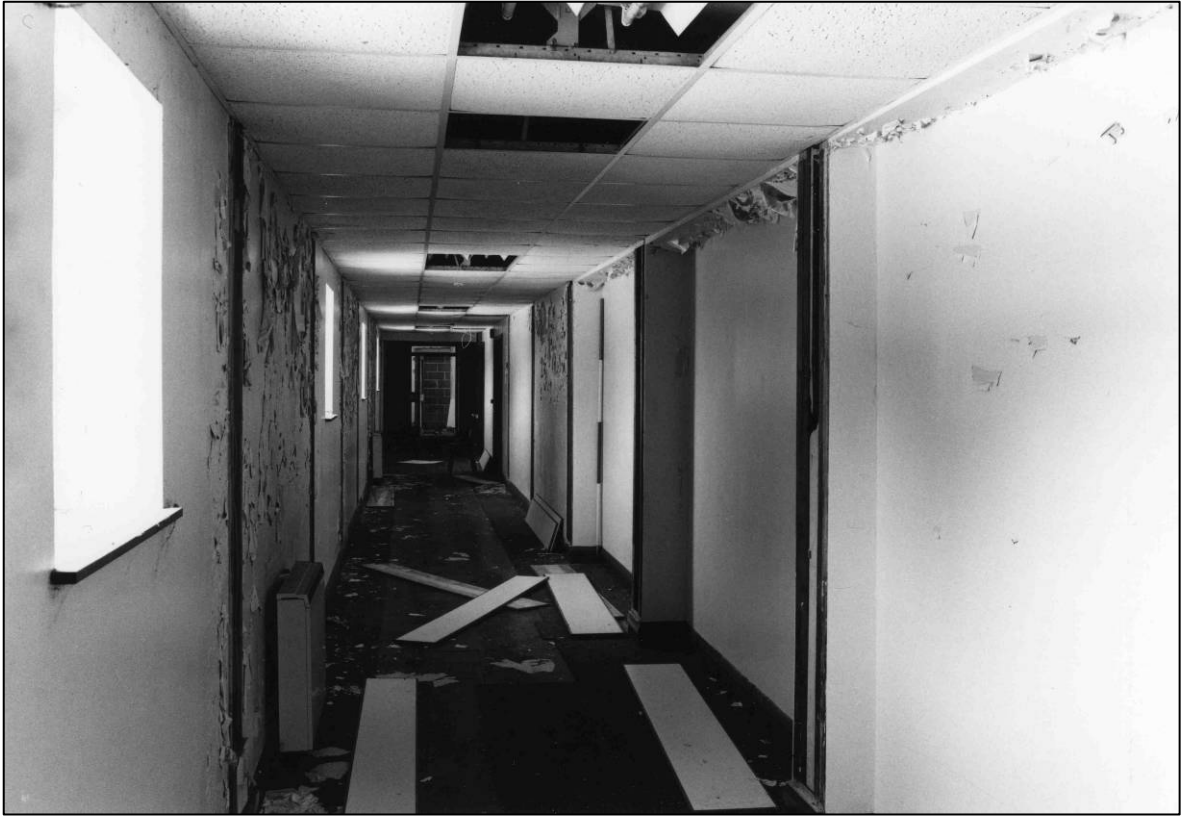
Plate 75: Corridor 1F6, looking SE (photo 3/15).

- 3.41 The main circulation spaces to the central part of the first floor are the corridors along the east side (**1F6**) (plate 75) (also giving access to room **1F5**) and north sides (**1F19**) (plate 76). Entry into the Control Room (**1F15**) or associated spaces from these corridors was strictly controlled, with all doorways fitted with a swipe-card security system; these cards were programmable, allowing entry to different areas to different people but still using the same system (Ray Hall, *pers. comm.*). A further east-west aligned corridor (**1F7**) branches off the west side of the main east corridor, giving access to a store (**1F8**), a probable meeting room (**1F13**) (plate 77) at the west end, and another room (**1F11**) to the north; the latter two rooms could only be accessed with the swipe-card system. The function of room 1F11 (plate 78) is uncertain - it has the same sound-proofing ceiling panels as are used in the Control Room (1F15), and also provides access to an internal lift, and a small and very plain subsidiary room (**1F10**).

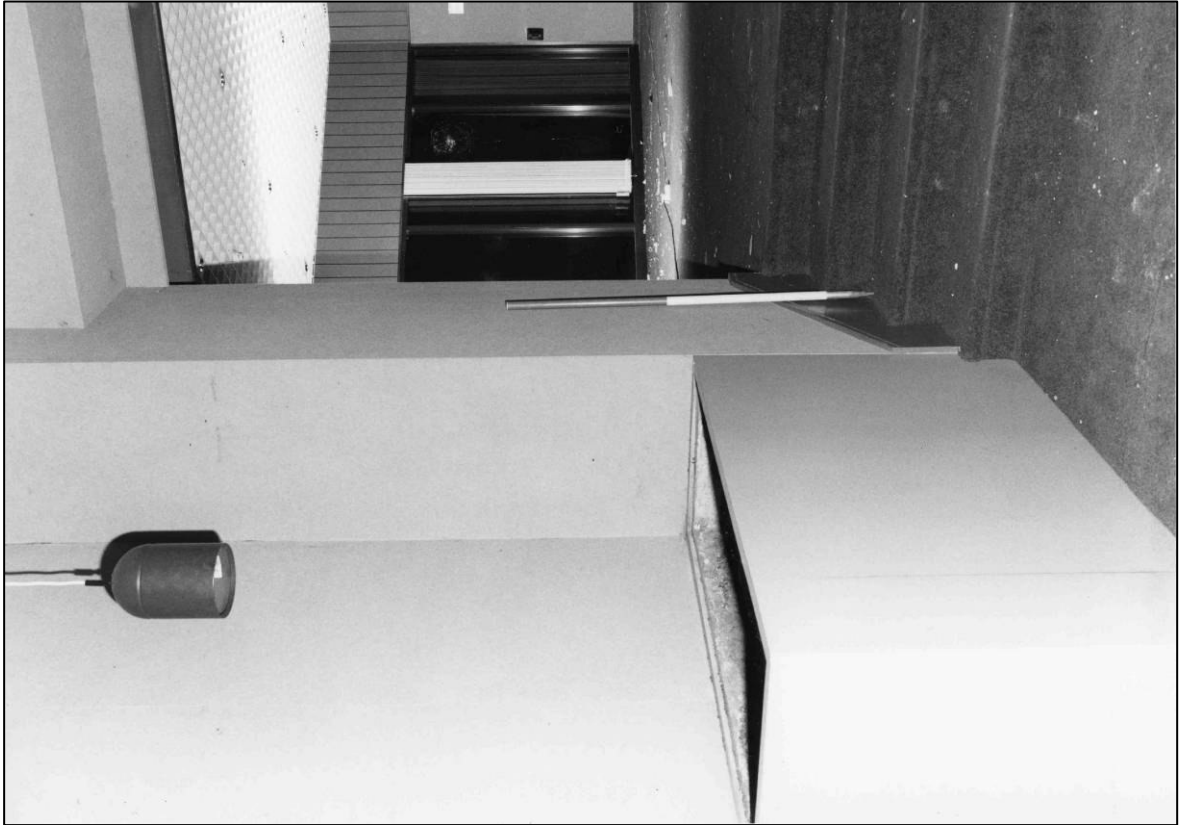
Plate 81: Circulation space (1F9), showing fittings, looking W (photo 2/3) (top to left).

short flight of steps rise up to the Viewing Gallery (1F14). The steps are flanked by waist-high metal troughs filled with soil, once containing plants (plate 81). Given the complete lack of natural light in the room, a lamp with a cylindrical shade was positioned over each of the troughs. Almost all of the north-west side of the Viewing Gallery (**1F14**) is formed by a glazed screen with slightly darkened glass, placed at an angle across the south-east corner of the Control Room (1F15) (plate 82). A panelled detail above the screen which resembles tongue and groove boarding is carried around all the wall-tops of the room, and the ceiling is of the same sound-proofing panels as used in the Control Room (1F15).

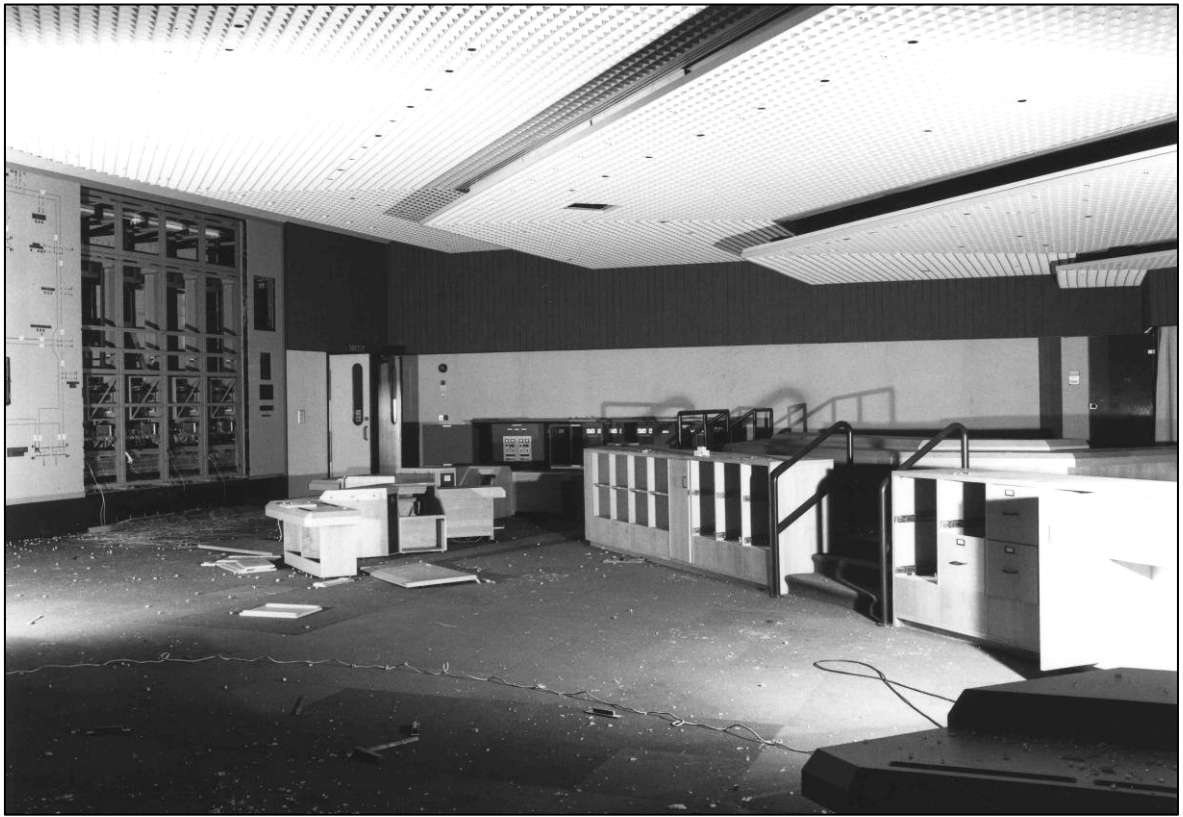
Plate 83: Control room (1F15), N end of mimic board and control desks, looking N (photo 1/12).

- 3.43 The Control Room itself (**1F15**) is the largest and by far the most impressive space within the whole complex, and it retained the highest proportion of contemporary equipment and fittings at the time of the survey (plate 83). This space housed the Area Control Room by the mid 1970s, but this was closed in 1983 and moved to the former West Yorkshire District Control Room in the northern part of the complex (see 1F25 below). The former Area Control Room was then refitted between 1983 and 1986 to become the existing Control Room but this did not become operational until 1993, as part of the National Grid's '5-Centre' plan (John Hughes, *pers. comm.*) (see figure 5 bottom); it replaced the Interim Control Room (room 1F25). The floor of the Control Room is covered with carpet tiles, below which is Cable Loft Area B; although it could not be accessed, it is almost certainly of the same form as Cable Loft Area C (see 1F21) i.e. a c.1m high space set between the ground and first floors and crossed by a grid of girders. The floor of the control room is divided into two parts. The upper, south-east part, houses a pair of U-shaped pine control desks (plates 84 and 85). At the canted edge of the upper area, there are two further pine desks which run parallel to the edge. Flanking the desks, and set between them, are low flights of steps leading down to the lower part of the room; tubular steel railings define the walkways down the steps. To the lower area, there is a pair of smaller U-or C-shaped pine desks to the north-east and a similar, single desk to the south-west. A photograph of the Control Room taken during the 1990s shows computer units standing to the front of each desk (see figure 5 bottom); the computer screens essentially duplicated what could be seen on the mimic board which dominates the Control Room. The walls of the Control Room are lined with the same board panels as noted elsewhere within the first floor, and have the same panelled detail above as noted to the Viewing Gallery 1F14. At the north-east corner of the room, there are four metal cabinets set against the east wall (plate 86). These have had their fronts removed which now stand loose; from south to north they are labelled 'SITE SECURITY SYSTEM', 'BOMB WARNING SIREN', 'MVAC MIMIC DIAGRAM' and 'DIESEL REMOTE CONTROL PANEL'. Above and to the side of these, a red light is mounted on the wall with a metal sign below stating 'WARNING - FLASHING BEACON DENOTES CONTROL ROOM FIRE BELLS SILENCED' (plate 87). The ceiling over the Control Room is of sound-proofing panels and is stepped upwards from south-east to north-west; it has a grid of spot-lights set into it, flush with the surface.

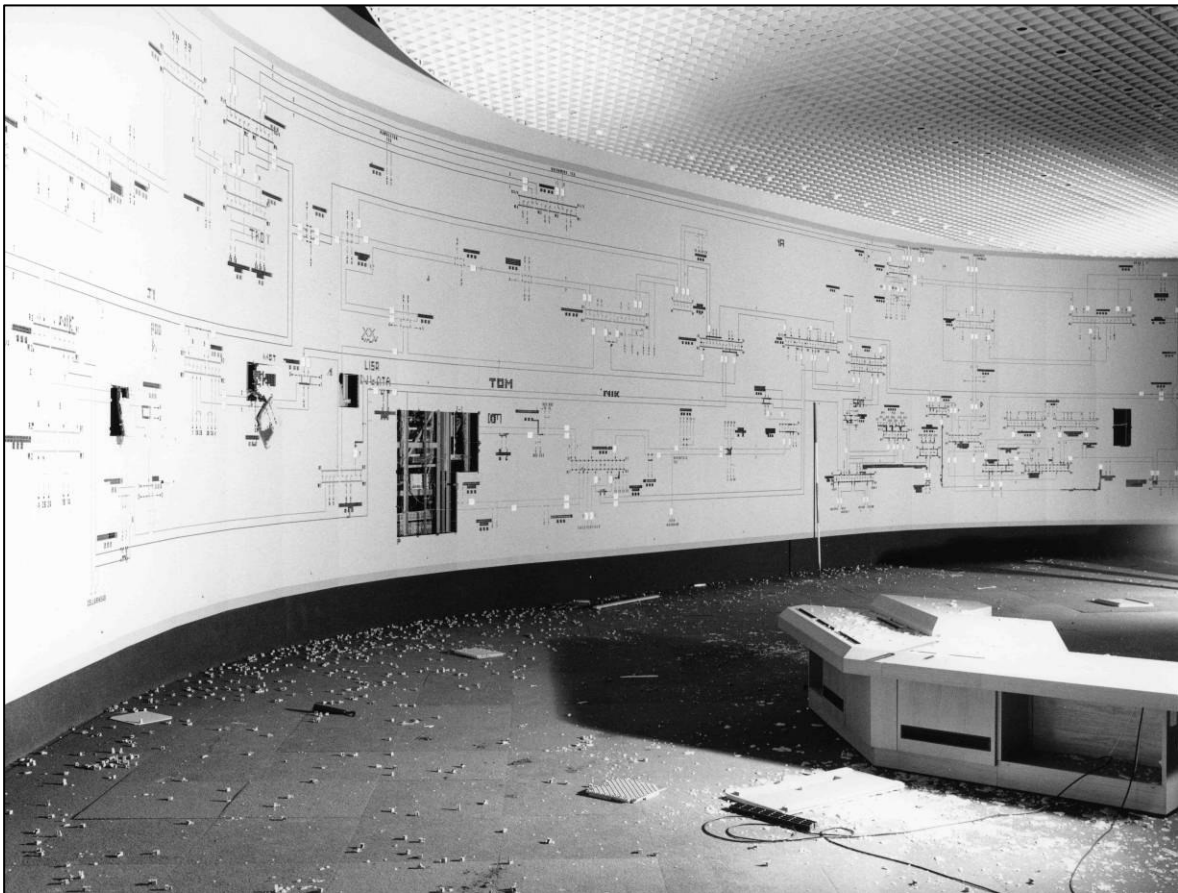
Plate 88: Control room (1F15), general view of mimic board, looking NE (photo 1/1).

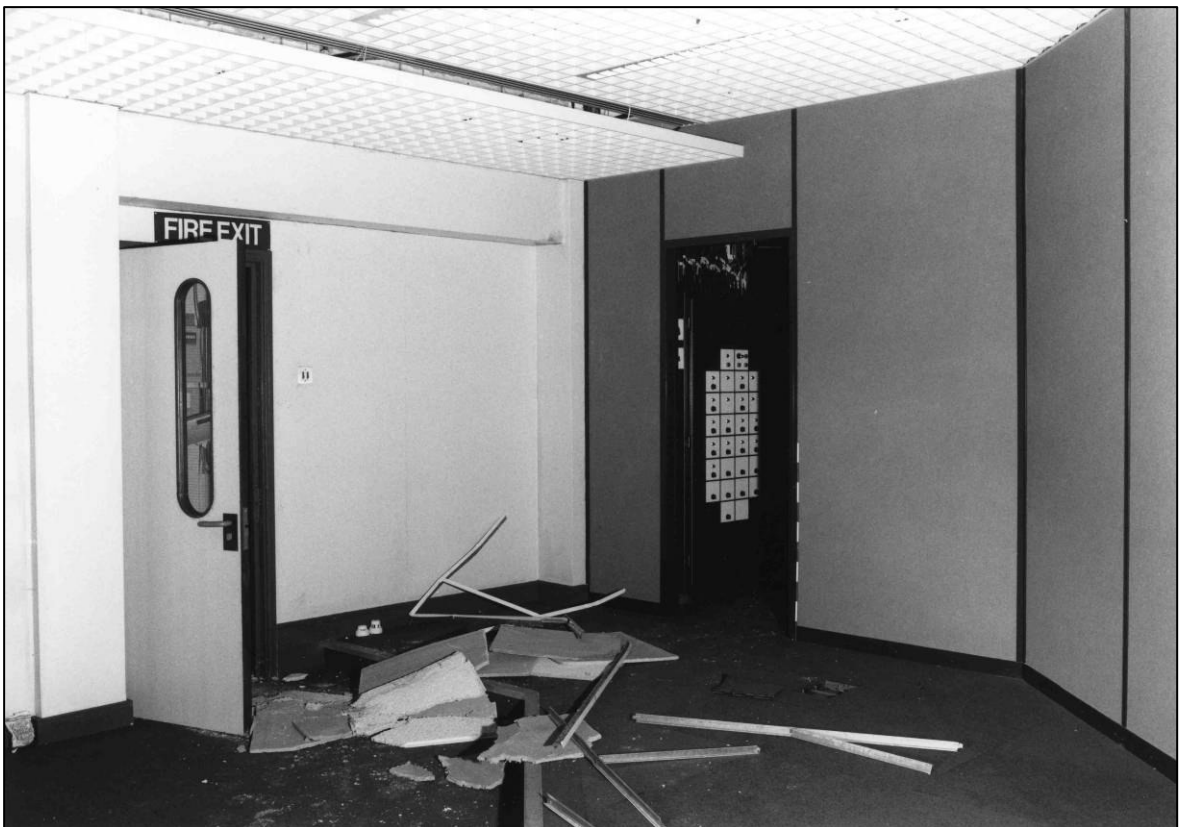
Plate 98: Triangular office (1F16), looking NE (photo 2/10).

- 3.46 The Triangular Office (1F16) (plate 98) to the north-west of the Control Room is accessed from corridor 1F19 via a doorway in the north wall fitted with a security swipe-card system on the outside. There is a raised area of floor around the south-east edge of the room and it is also equipped with sound-proofing ceiling panels, stepping upwards from north-west to south-east. Doorways in the east and south walls lead through to equipment housed in an area between the room and the rear of the mimic board. Through the south door, a series of metal cabinets house AC and DC isolators (plate 99), as well as controls for the lights in the Control Room area. Through the east door, further metal cabinets house controls for heating, air-conditioning and ventilation units (plate 100); one is labelled 'H & V PANEL CPI'. On the west side of the Control Room, there is a corridor (1F17) and Mess Room (1F18) (plate 101); map evidence indicates that these were built after 1993.

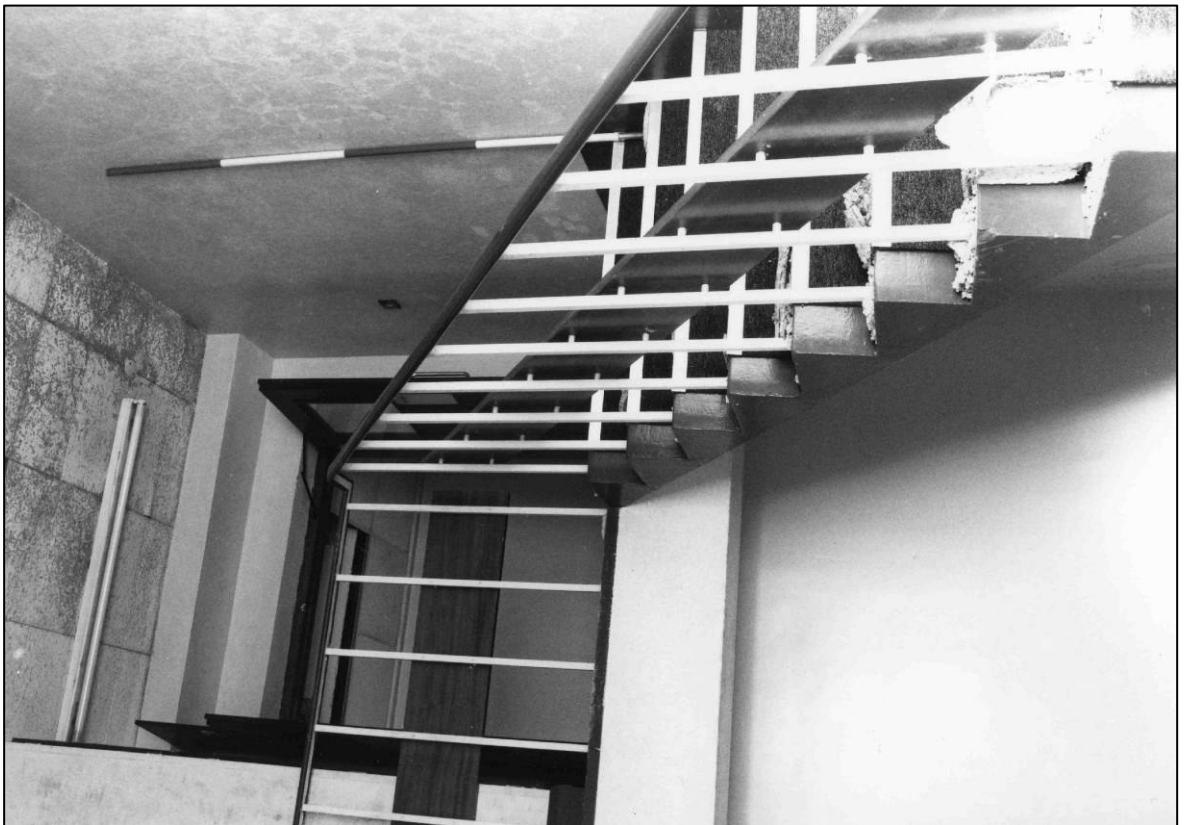
Plate 102: Staircase 1F23, looking SW (photo 2/18) (top to left).

- 3.47 The majority of the rooms in the northern part of the first floor are all accessed from the north corridor 1F19, which is also linked to the northern first floor stairway (1F23) (plate 102) and room 1F24 (plate 103) to the immediate east. The north-west corner of this part of the complex is largely formed by office space for Asset Management (rooms 1F20, 1F21 and 1F22) (plates 104 and 105), below which is Cable Loft Area C; as with other similar areas elsewhere, this is c.1m in height and is crossed by lattice girders of composite angle-steel construction (plate 106). Just outside the swipe card door entry into the Asset Management suite, in corridor

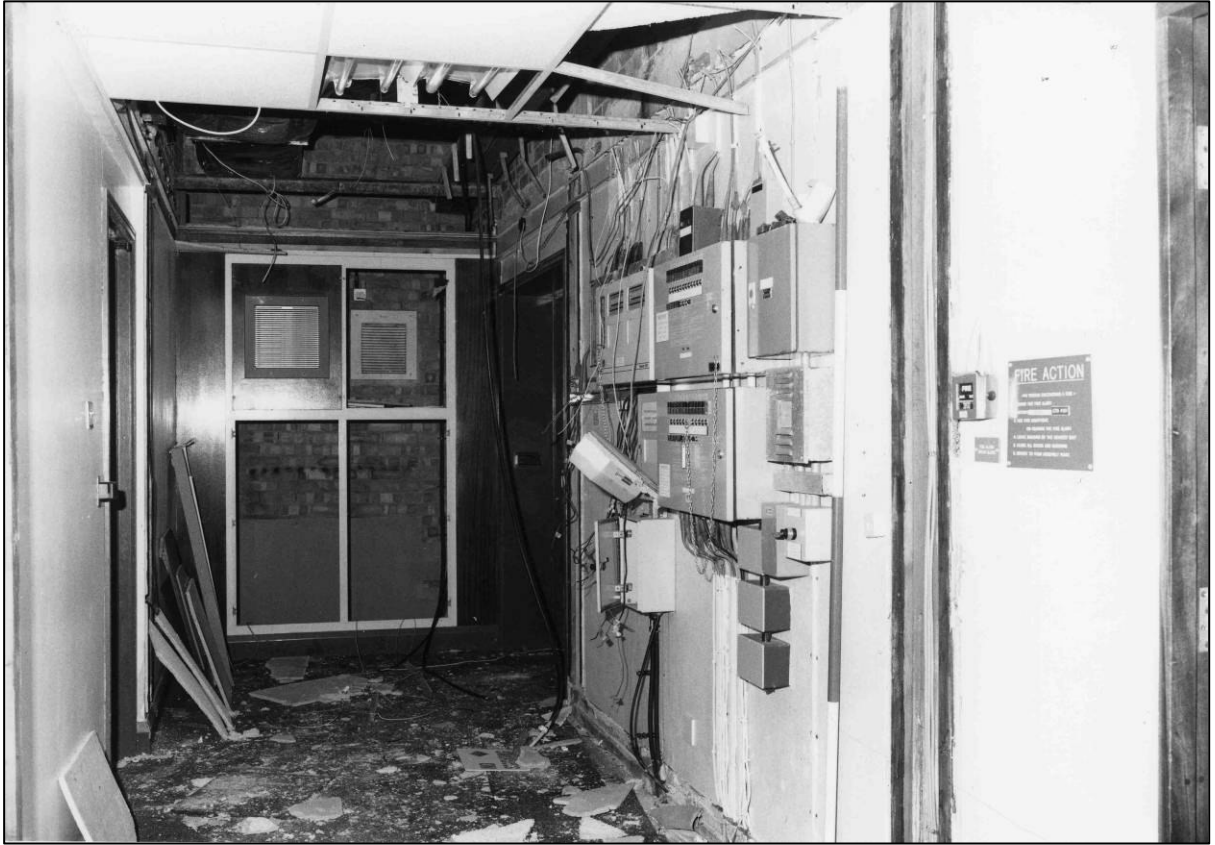
Plate 107: Corridor 1F19, fire alarm panels, looking NW (photo 2/17).

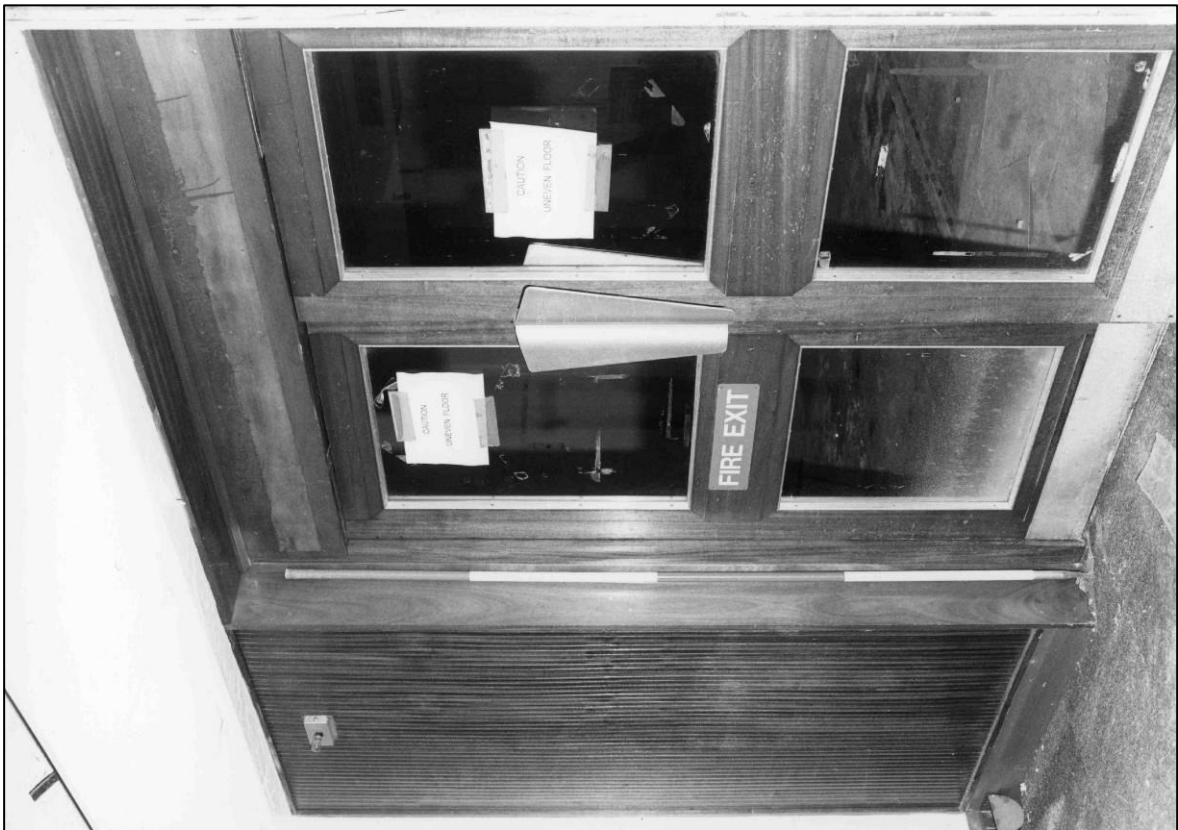
Plate 108: Interim Control Room (1F25), doorway from corridor 1F19, looking W (photo 3/3) (top to left).

- 3.48 The north-east corner of the first floor comprises a single space (**1F25**), formerly the Interim Control Room. In the mid 1970s, this room formed the West Yorkshire Control Room, one of two district control rooms within the control centre. However, in 1983 it was converted into the Interim Control Room, while the former Area Control Room (1F15) was refitted. This refit was completed by 1986 but the Interim Control Room remained in use until 1993 when the existing Control Room (1F15) became operational (John Hughes, *pers. comm.*). The room is accessed from corridor 1F19 through a doorway in the south wall, fitted with a security swipe card system externally and retaining a pair of doors unlike any others surviving within the complex - each door has two glazed panels and a curved steel handle (plate 108). To the immediate west of the doorway, there is a panel of varnished corrugated woodwork, like that seen over the doorway at the south end of the west side of corridor GF8 on the ground floor. At a high level, a metal box is mounted on the woodwork, from which a bare bulb projects.

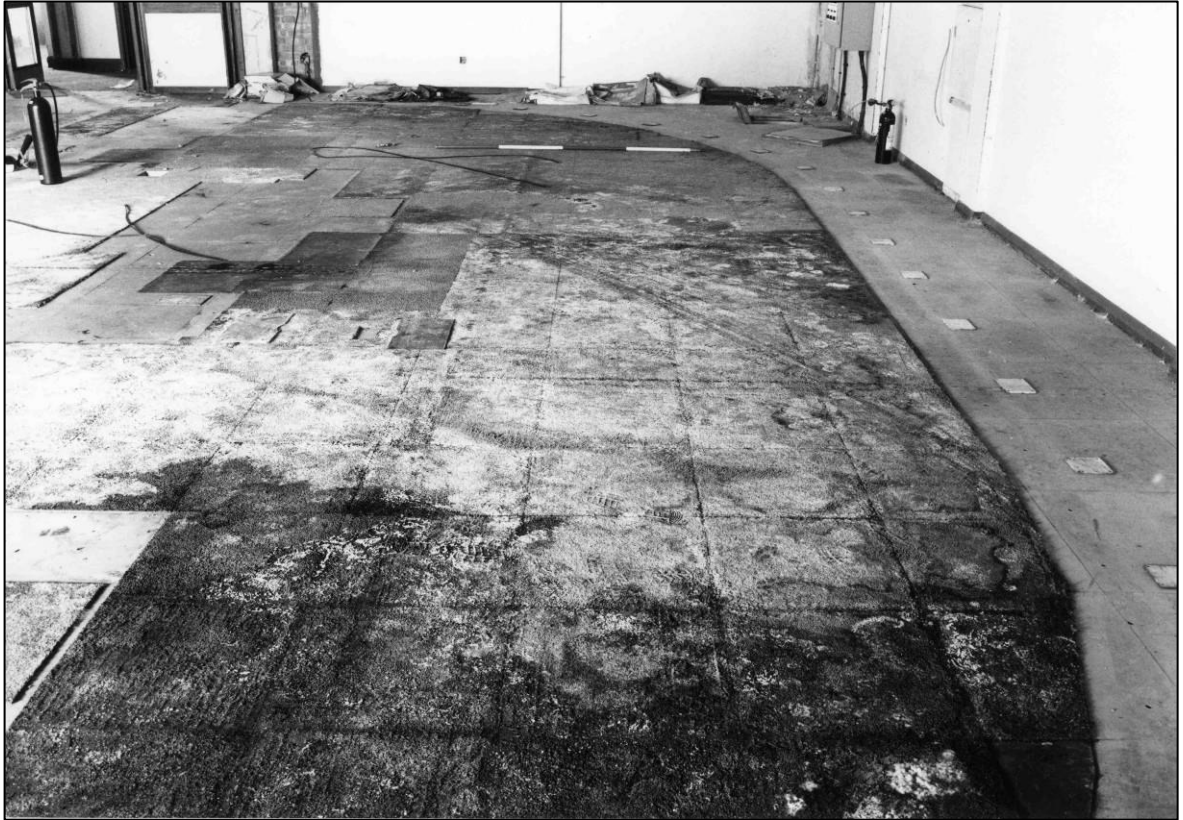
Plate 109: Interim Control Room (1F25), curve of former structure to W side, looking SW (photo 3/10).

- 3.49 The interior of the Interim Control Room had been partly stripped out when the EDAS survey took place, exposing elements of the internal construction. The floor is covered with carpet tiles, but at the south-east and south-west corners, floor traps provide access to the below-floor space, which may form Cable Loft Area A; it is very similarly structured to Cable Loft Area C noted above. The carpet tiles form two broadly semi-circular areas, separated by a narrow walkway which runs north-south across the room. At the outer edge of both semi-circular areas, there is a row of small square metal plates (plate 109). These formed the bases for uprights, which once comprised part of curved mimic boards projecting from the east and west walls of the room; the steel beams which formed the horizontal element of the board have been cut back flush with the wall face, where their ends are still visible. Each board was apparently of two levels, and electrical plug sockets are set into the wall at the approximate height of where the base of the upper level would have been; one board formed a diagram of sub-station layers while the other was an overview diagram (John Hughes, *pers. comm.*).
