FORMER CEGB CONTROL CENTRE,  
BECCA HALL, ABERFORD,  
WEST YORKSHIRE

BUILDING RECORDING

Report no: 2012/436.R01  
Version: Final  
Date: October 2012  
Author: Shaun Richardson & Ed Dennison

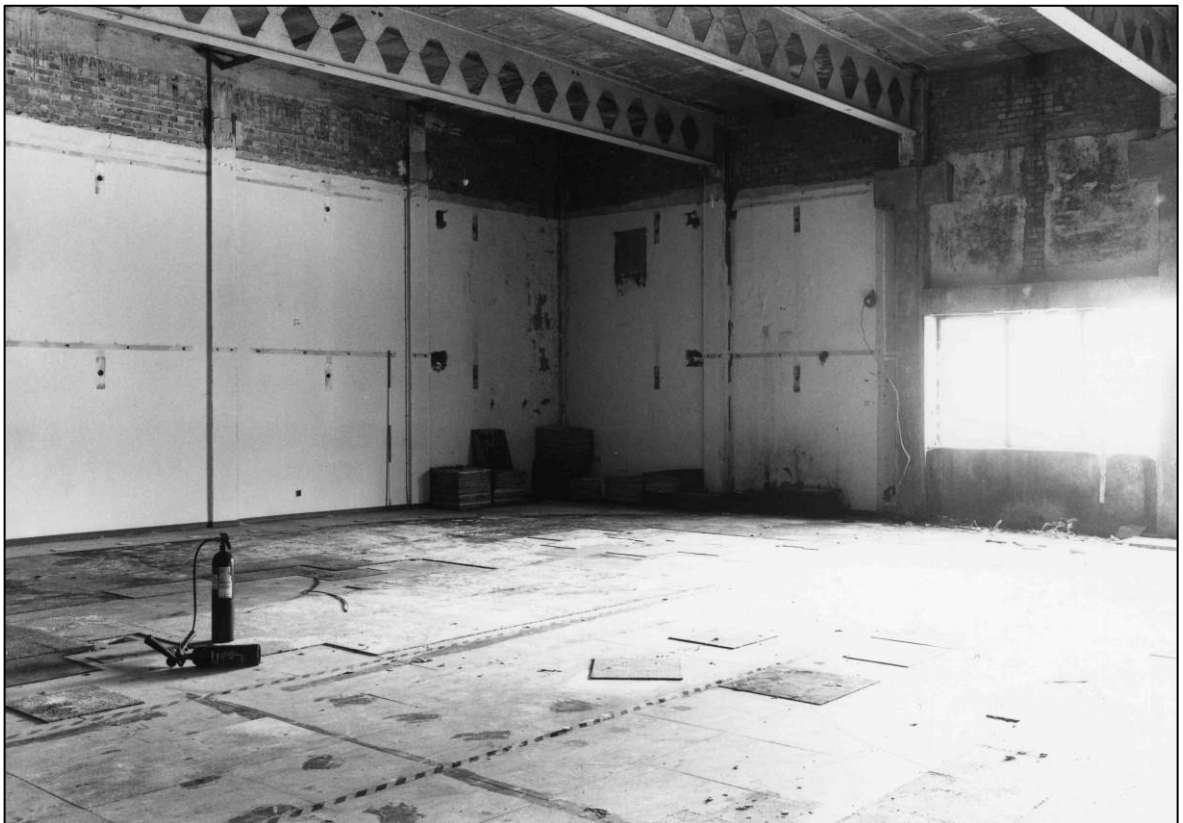
Plate 110: Interim Control Room (1F25), looking W (photo 3/6).

- 3.50 The walls of the room are plastered behind where the mimic boards would have stood, but above, panels of bare brickwork are visible, comprising brown machine made bricks laid in English Bond and set with a cement mortar (plate 110 and 111). The panels of brickwork run between the uprights of the concrete frame. These are all of the same form, and rise to the concrete ceiling (plate 112), apart from in the north wall. Here, a two-light window (with a later inserted door leading to an external fire escape) is set between three uprights (plate 113). The lintel of the window is formed by a substantial horizontal concrete beam which appears to be contemporary with the uprights; c.1m above the lintel, the uprights incorporate a thickened horizontal cross-piece, essentially forming a T-shaped 'head' (plate 114). The uprights continue above this 'head' as before to ceiling level, but it could not be determined if these upper ends are of the same date i.e. if the roof has been raised at some point or not. The uprights to the north and south walls support four north-south aligned steel girders. These girders are slightly cambered, increasing in height towards the centre, and are pierced by regularly spaced hexagonal openings (plate 115). The same girders are visible over the rear north-west area of the Control Room (1F15). The only piece of electrical equipment to survive within the room is located at the south-west corner, where two metal cabinets house the controls for the Interim Control Room's heating and air-conditioning systems (plate 116).

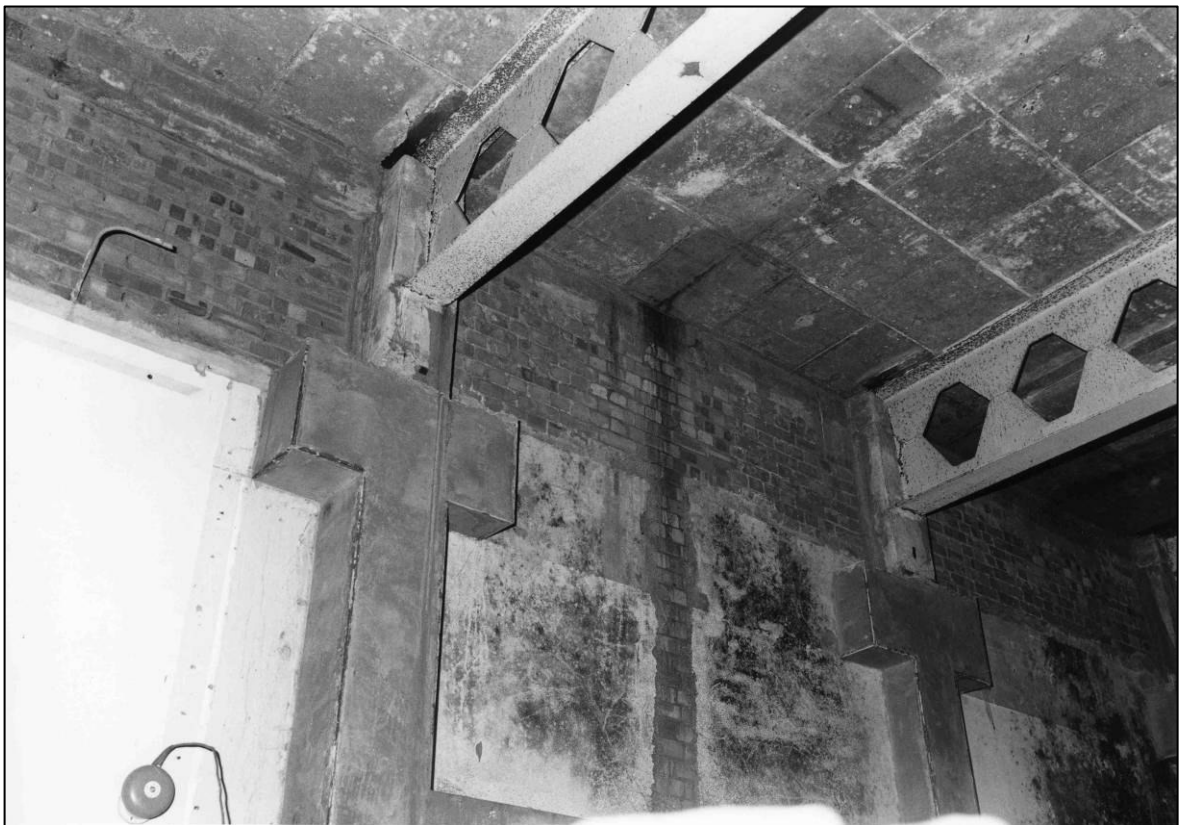
Plate 114: Interim Control Room (1F25), concrete frame and girders to N wall, looking N (photo 3/11).

- 3.49 The interior of the Interim Control Room had been partly stripped out when the EDAS survey took place, exposing elements of the internal construction. The floor is covered with carpet tiles, but at the south-east and south-west corners, floor traps provide access to the below-floor space, which may form Cable Loft Area A; it is very similarly structured to Cable Loft Area C noted above. The carpet tiles form two broadly semi-circular areas, separated by a narrow walkway which runs north-south across the room. At the outer edge of both semi-circular areas, there is a row of small square metal plates (plate 109). These formed the bases for uprights, which once comprised part of curved mimic boards projecting from the east and west walls of the room; the steel beams which formed the horizontal element of the board have been cut back flush with the wall face, where their ends are still visible. Each board was apparently of two levels, and electrical plug sockets are set into the wall at the approximate height of where the base of the upper level would have been; one board formed a diagram of sub-station layers while the other was an overview diagram (John Hughes, *pers. comm.*).

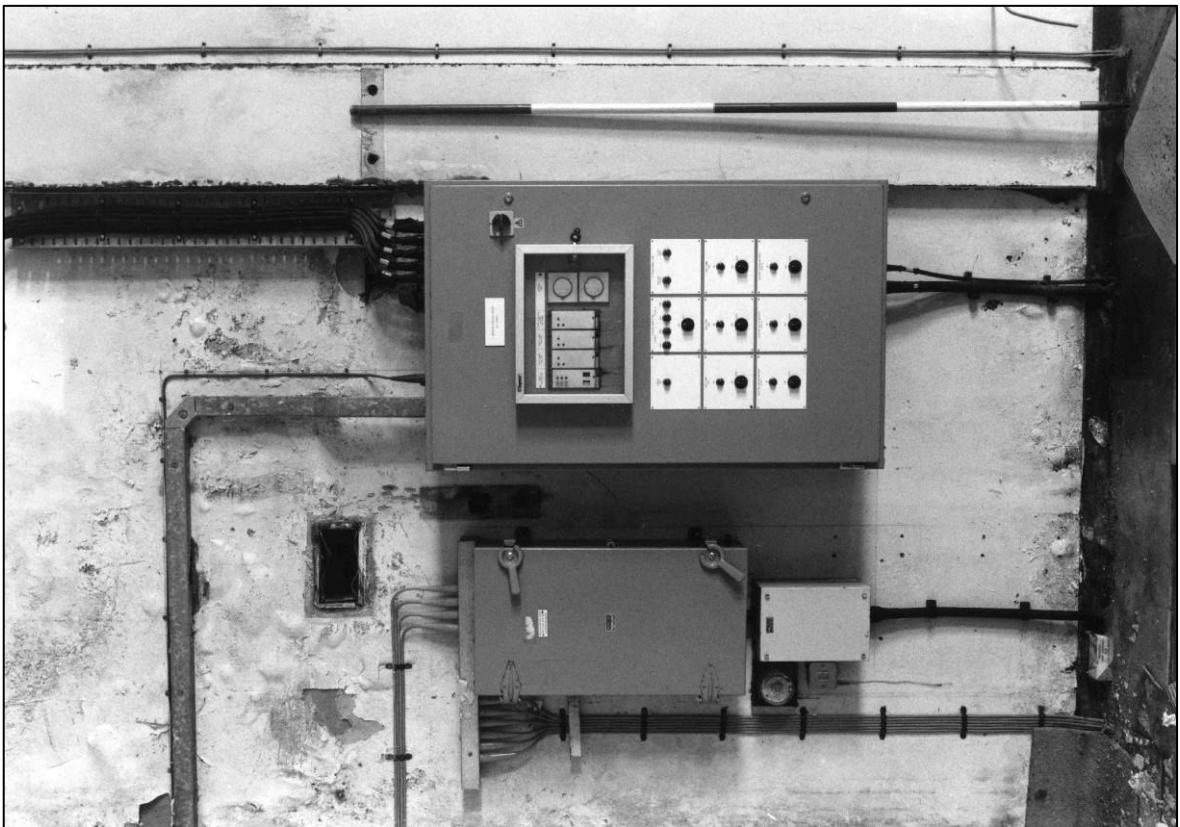
Plate 116: Interim Control Room (1F25), control panels to SW corner, looking SW (photo 3/9) (top to left).

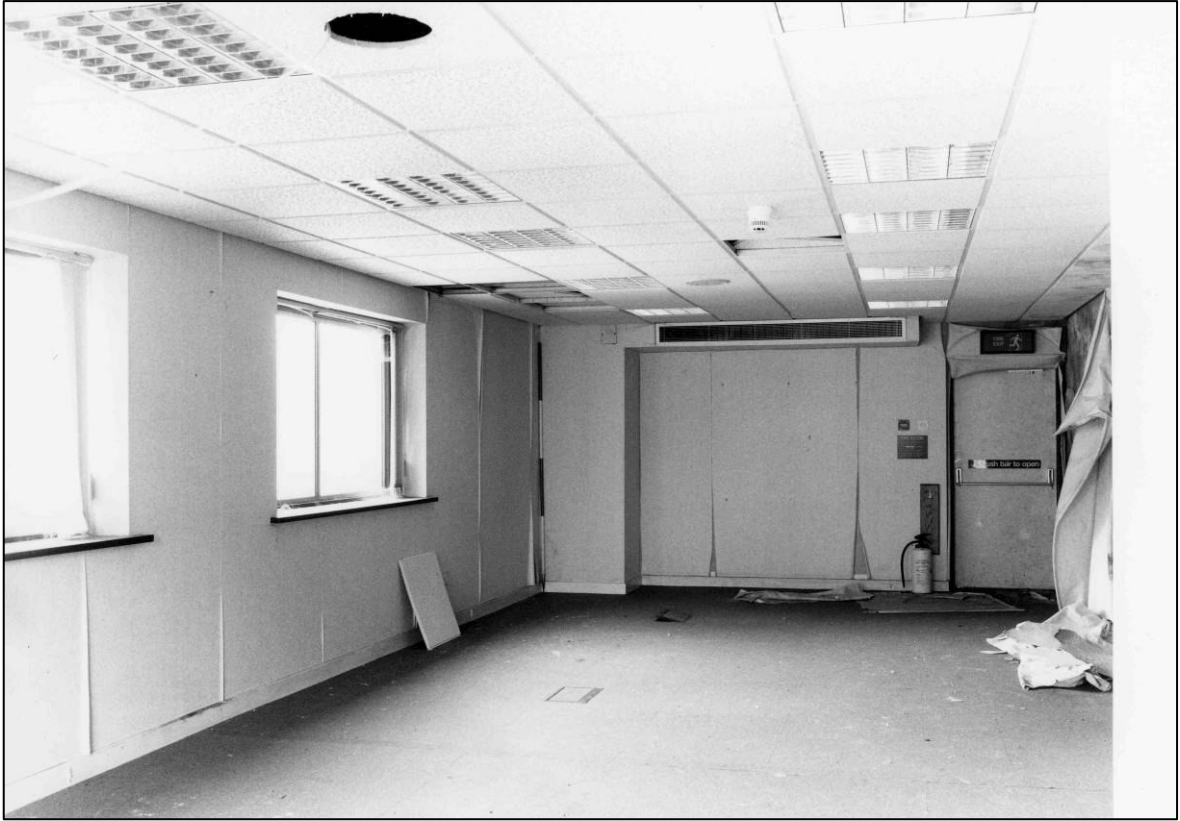
Plate 117: Room 2F1, looking NE (photo 2/15).

- 3.51 The second floor area (**2F1**) of the control centre is very small, and exists only as a single room in the north-west corner, over room 1F22 of the Asset Management suite below. It is accessed via a staircase rising from room 1F21 on the first floor. The room is lit by windows in the north and west walls, and has a doorway leading to an external fire escape to the east wall (plate 117).
